MOUNTAIN SPRINGS LAKE DAM

NDI ID NO. PA-00770
DER ID NO. 45-42

PHASE I INSPECTION REPORT
NATIONAL DAM INSPECTION PROGRAM

JANUARY 1980

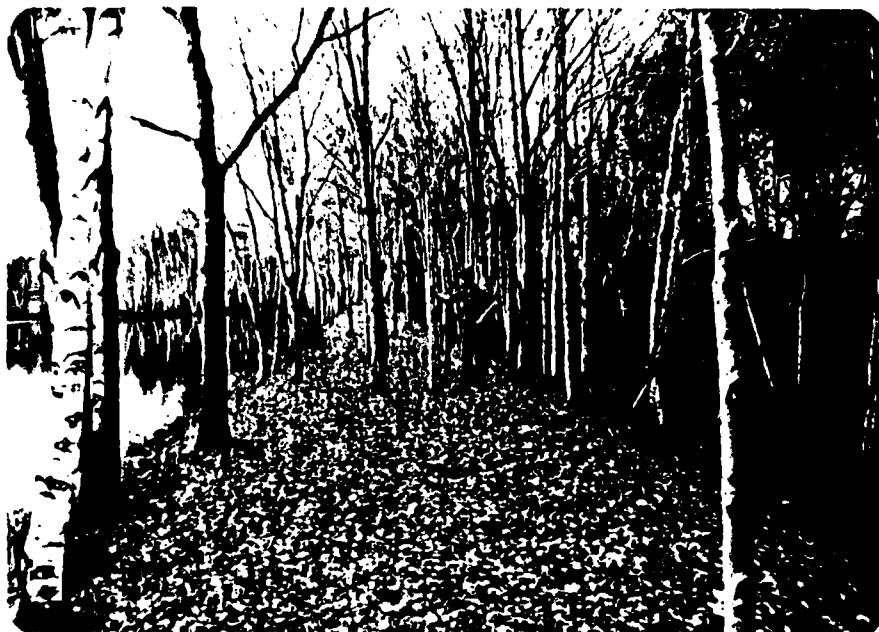
A. Top of Dam

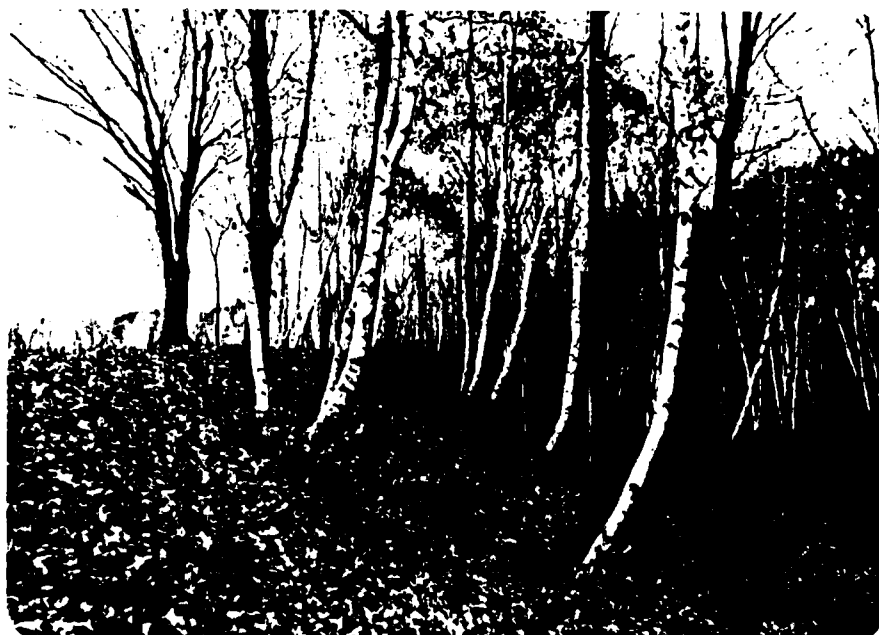
The two wet areas and the swampy area at the toe of the dam appear to be similar in character and extent to conditions described in previous inspection reports between 1919 and 1966. Proper collection and disposal facilities for the water are needed so that any change in condition or quantity can be detected.

B. Downstream Slope of Dam

(4) Provide properly designed facilities to safely collect and dispose of standing water along the toe of the dam. The facilities should include measurement devices. Any seepage flow should be monitored, and records should be maintained.

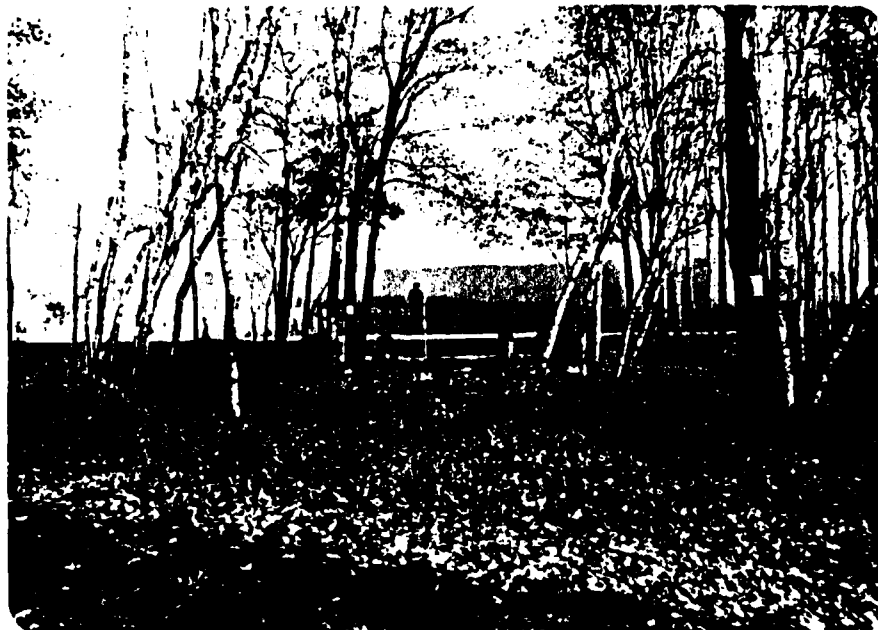
F. Spillway
